NPIC/R-1074/64

January 1964

PHOTOGRAPHIC INTERPRETATION REPORT

# MUNITIONS STORAGE SITE NEAR HUANG-PEI, CHINA

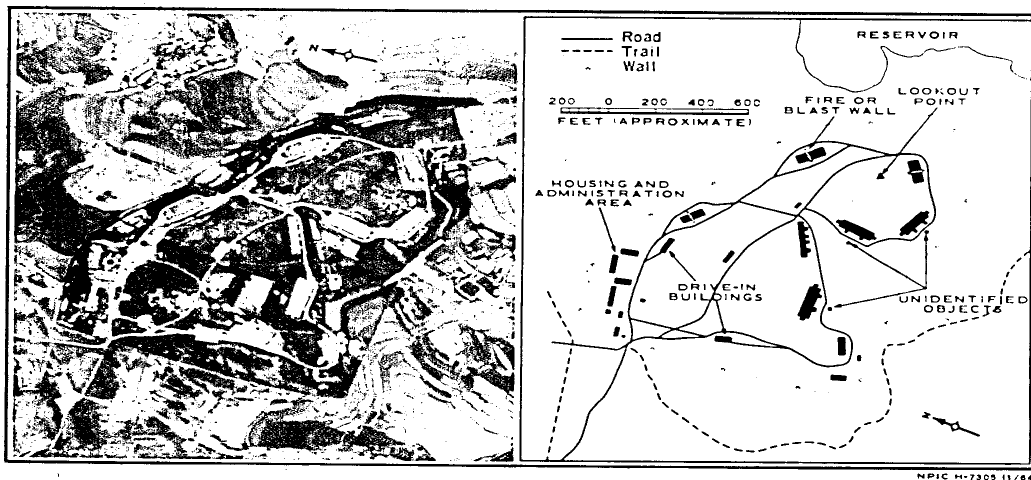
FIGURE 2. MUNITIONS STORAGE SITE NEAR HUANG-PEI, CHINA, [REDACTED]

**Storage Buildings.** This site contains six large warehouses and six smaller storage or support buildings (Figure 2). All these buildings have gable roofs. Three of the large warehouses are divided into two unequal sections by fire or blast walls. Every section has a ventilator at the roof peak and a separate entrance. The roofs of these buildings have a speckled appearance. No ventilators were discernible on the other three warehouses, which have four entrances each. A perspective of the two types of warehouses is given in Figure 3. An unidentified object is adjacent to each of the three warehouses without ventilators. The objects appear to be filled with a liquid and resemble open wells or storage tanks; their purpose may be to supply water in case of a fire. The six warehouses range in size from 170 by 35 ft to 135 by 45 ft and have a total roof coverage of 46,000 sq ft. The six

storage or support buildings include two drive-in buildings and a long, narrow building (190 by 40 ft) with four entrances on the side facing the road.

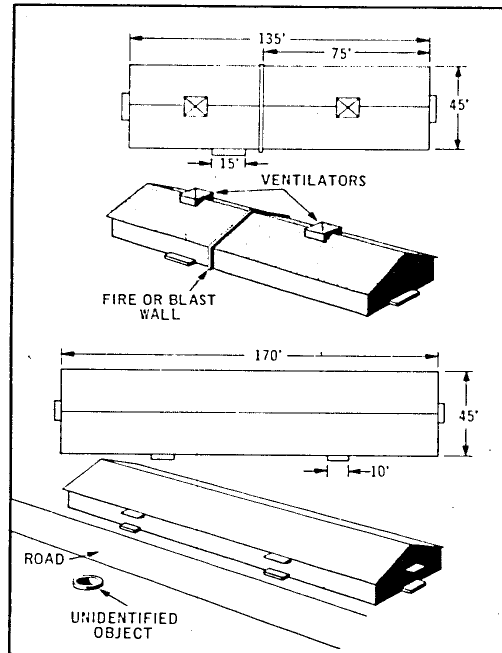
FIGURE 3. TWO TYPES OF WAREHOUSES OBSERVED AT
